DETECTING COMPOSITE IMPACT DAMAGE DURING STORAGE AND HANDLING

Pamela Kay Strong¹ and Mackenzie Lynn Miller²

¹United Launch Alliance
8100 Southpark Way
Littleton CO 80120

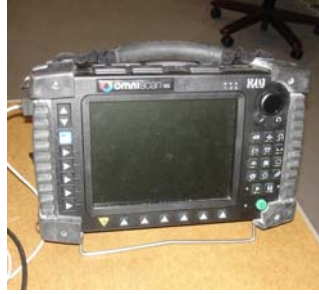
The experiment was to test Pressurex® film's ability to indicate a composite impact. The results of the film, after a force was applied, were compared to that of an established nondestructive evaluation method, i.e. A-scan, see Figure 2. The ultrasonic A-scan method uses two transducers to detect any damage between them. This technique was the most accessible, cheapest available, and required the least amount of time for this type of experimentation. Damage was determined to be present using this device when the number of ultrasonic waves passing through the composite was fewer than the amount that went through an undamaged piece of composite. The transducers must be coated with enough couplant solution so this device does not identify false damage due to an air pocket between the transducer and the composite surface.

Figure 2: Ultrasonic A-Scan with 2 transducers

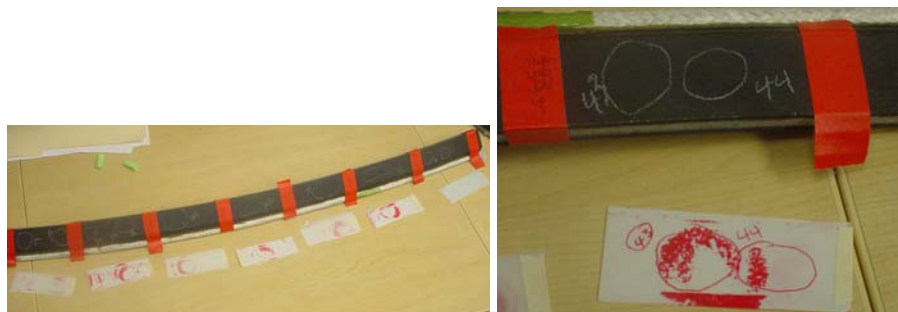
Before testing the film, the sample composite pieces were submitted to A-scan to ensure that they were initially intact. The composite was wiped down with MEK solvent to remove dirt and residual A-scan couplant which might have adversely affected the results. Solvent wiping is also an established practice when working with aerospace parts. The designated impact indication film was applied to the composite sample in strips. The film was applied in a non-overlapping manner with the alternating film matte and glossy side towards the composite. This was to test which side; glossy or matte, best illustrated the damage. The strips of film were taped down and numbered, see Figure 4.

Figure 4: Strip #2 - entire length (left), close-up on one section (right)

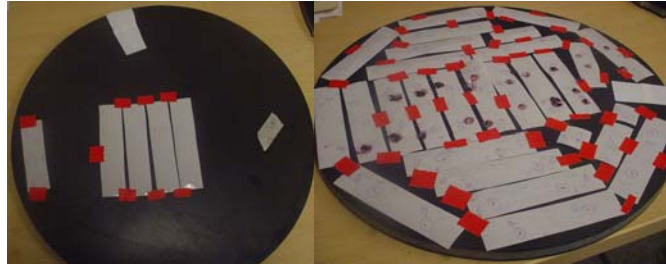
The results were recorded as either glossy or matte along with the applied impact pressure. After it was determined that matte side toward the composite was a better arrangement of the film, the circular piece, with approximately 1/2" core sandwiched by 1/16" graphite laminates, was then tested with strips of the high rated film, matte side down and taped in place. Four strips of high rated film were also taped to the back of the circular composite piece to test whether the film would pick up the impact damage from the other side, see Figure 5.

Figure 5: Circular piece #1- front (left), back (right)

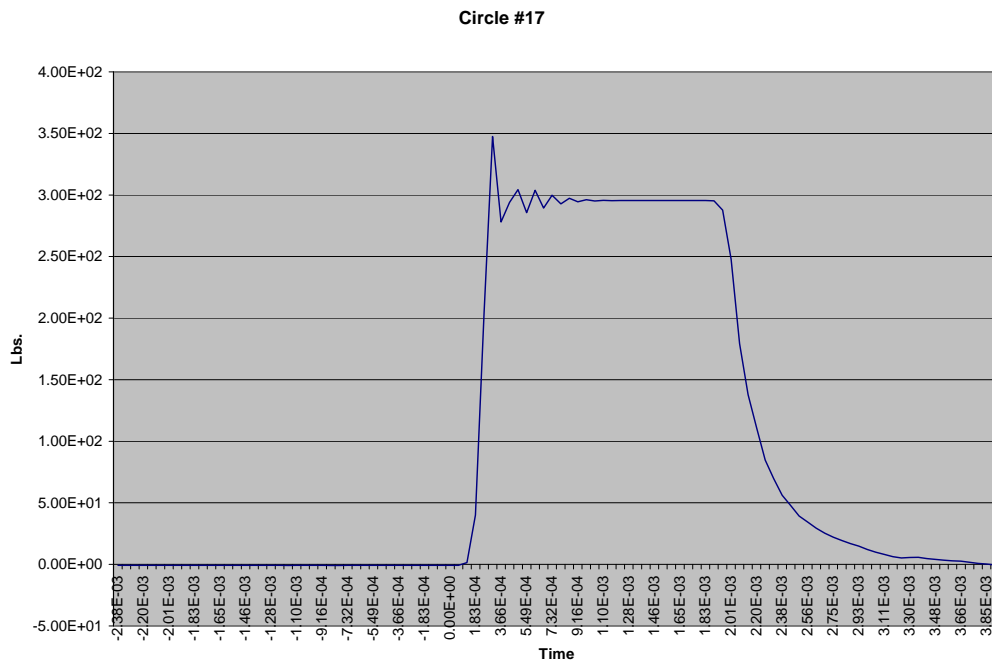
to leave stray marks from handling along the matte film side. On the glossy side of the film, these stray marks showed less because the glossy covering prevented access to the pigment. The second outcome was the film failed to react to impact damage on the opposite side of the sandwich composite. The third and fourth outcomes became evident following the final A-scan. The A-scan confirmed where damage had occurred, but the area of actual impact damage was larger than the film indicated, as the third outcome. The fourth outcome was that the A-scan revealed the minimum force range for the composite pieces, using two different graphite sandwich thicknesses that had to be impacted with in order to be damaged. All damaged composite pieces that showed A-scan impact damage experienced 300+ pounds (10,067+ psi). The dynamic signal analyzer recorded the peak force before any damage was done to the ply (see Circle #39). At the point of damage, the signal was broken up and only the dissipation of the impact force was recorded appearing as noise (see Circle #17). The composite might have been struck with a larger force but the analyzer only documented up to the force it took to fracture the top ply. Not all pieces impacted with 300+ pounds were damaged; this therefore was indicated as a false positive by the high-rated film. However, there were no damaged composite pieces struck with anything less than 300 pounds and therefore there were no false negatives in which the high-rated film indicated no impact damage when there was damage present. The following tables display the composite impacts that did damage, Table 1, (all strikes within the range of the high rated film, 7,100-18,500 psi) and the rest of the composite impacts within that range of the high rated film that were determined undamaged by the A-scan, Table 2, dissipation of the impact force (see Circle #39):

Figure 6. Impact Damage Table 1

Impact #	lb_f	PSI	Damage
c10	298.25	10,008.22	yes
c5	313.75	10,528.52	yes
c19	315.04	10,571.88	yes
s87	319.92	10,735.47	yes
s88	319.92	10,735.47	yes
c4	320.13	10,742.68	yes
s90	325.77	10,931.91	yes
c9	326.30	10,949.63	yes
c24	326.44	10,954.23	yes
c2	329.63	11,061.31	yes
s94	331.02	11,107.99	yes
c18	331.27	11,116.51	yes
s93	332.94	11,172.35	yes
s82	333.78	11,200.60	yes
c14	333.95	11,206.51	yes
c23	333.99	11,207.82	yes
c8	335.89	11,271.54	yes
s95	335.91	11,272.21	yes
c13	336.36	11,287.32	yes
c11	337.13	11,312.95	yes
c22	337.19	11,314.93	yes
c16	340.49	11,425.94	yes
c1	342.96	11,508.72	yes
s77	343.33	11,521.21	yes
c15	344.00	11,543.56	yes
c12	346.90	11,640.77	yes
c17	347.52	11,661.78	yes
c7	347.84	11,672.32	yes
s84	348.48	11,693.99	yes
s83	349.30	11,721.58	yes
s96	349.38	11,724.19	yes
s92	350.77	11,770.84	yes
c3	351.34	11,789.90	yes
c20	351.52	11,795.81	yes
c6	354.08	11,881.88	yes
