UNIVERSITY OF MINNESOTA
ST. ANTHONY FALLS HYDRAULIC LABORATORY

Project Report No. 343

**Investigation of the Use of Air Injection
to Mitigate Cavitation Erosion**

Pacific Gas and Electric Company
San Francisco, California

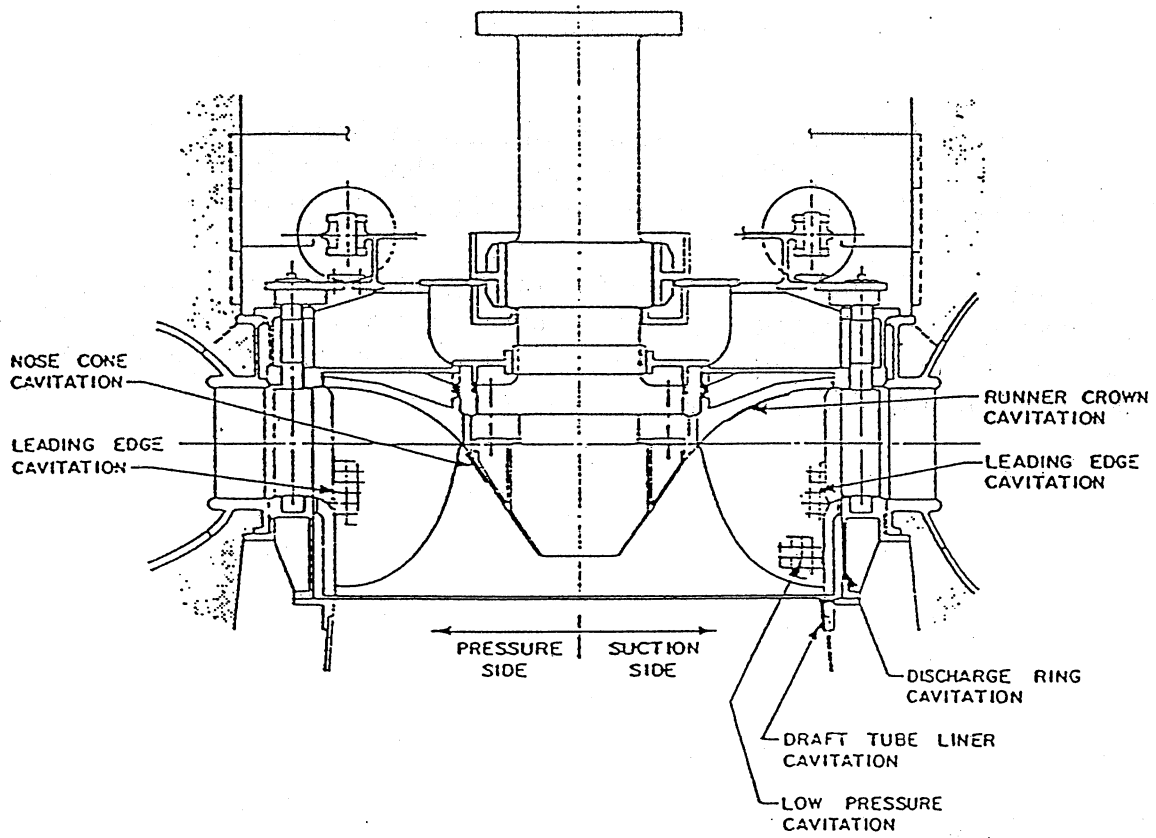
Figure 1a. Typical cavitation erosion patterns on a Francis turbine unit ($N_s \approx 1$).

As illustrated in Figure 1a, which is a generic schematic for a turbine in this specific speed range (non-dimensional $N_s \approx 1$), leading edge cavitation erosion on both the suction and pressure sides of the runner as well as erosion at the trailing edge of the buckets is common. Field inspection indicates that the Kerckhoff 2 runner exhibits similar patterns of erosion, as shown in Figure 1b. This erosion occurs in spite of the fact that the plant sigma is adequate according to USBR field experience (c.f. Arndt, 1990).

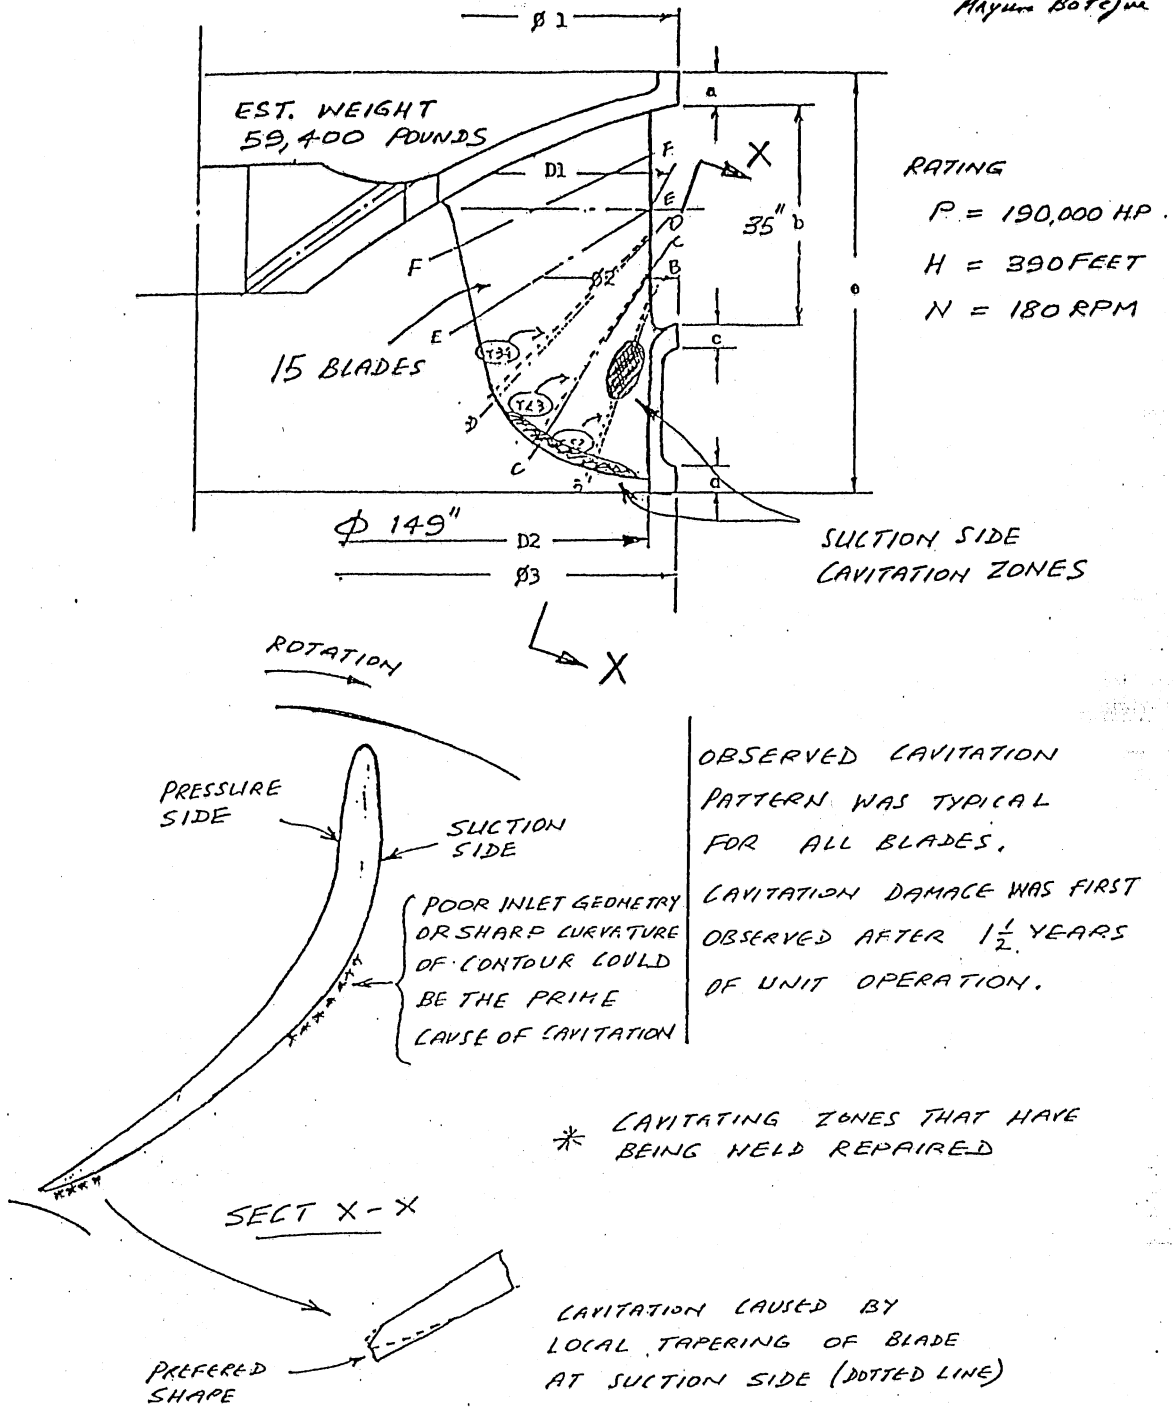
KERCKHOFF 2 RUNNER INSPECTION

Figure 1b. Cavitation erosion patterns on Kerckhoff 2 runner observed in field inspection (personal communication, Mayura Botejue, PG&E).

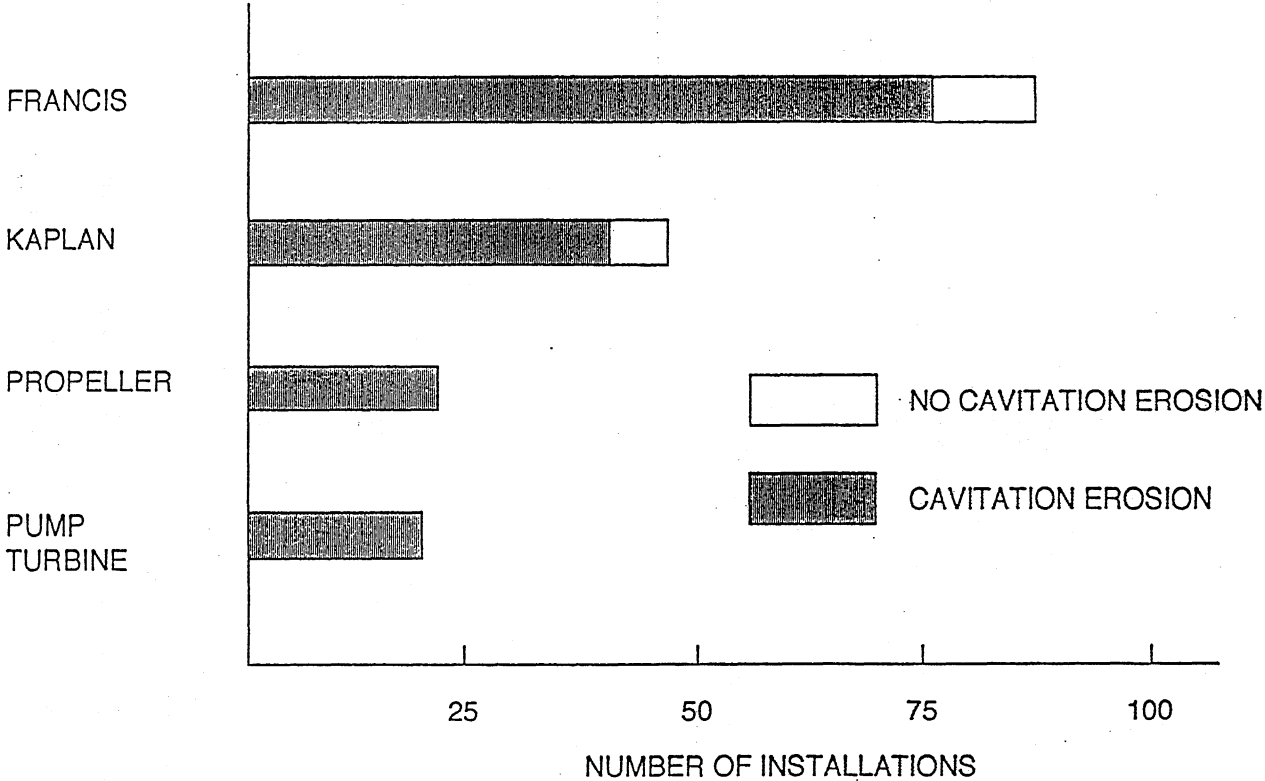
EROSION OCCURRING IN HYDRAULIC TURBINES IN USA

Figure 2. Results of a field study on cavitation erosion in turbines (adapted from Arndt et al, 1989).

Arndt et al (1989) studied the extent of the problem under EPRI sponsorship. Their work is based on a field survey of the operational and design characteristics of 729 hydro-turbines installed since 1950 having either a capacity greater than 20 MW

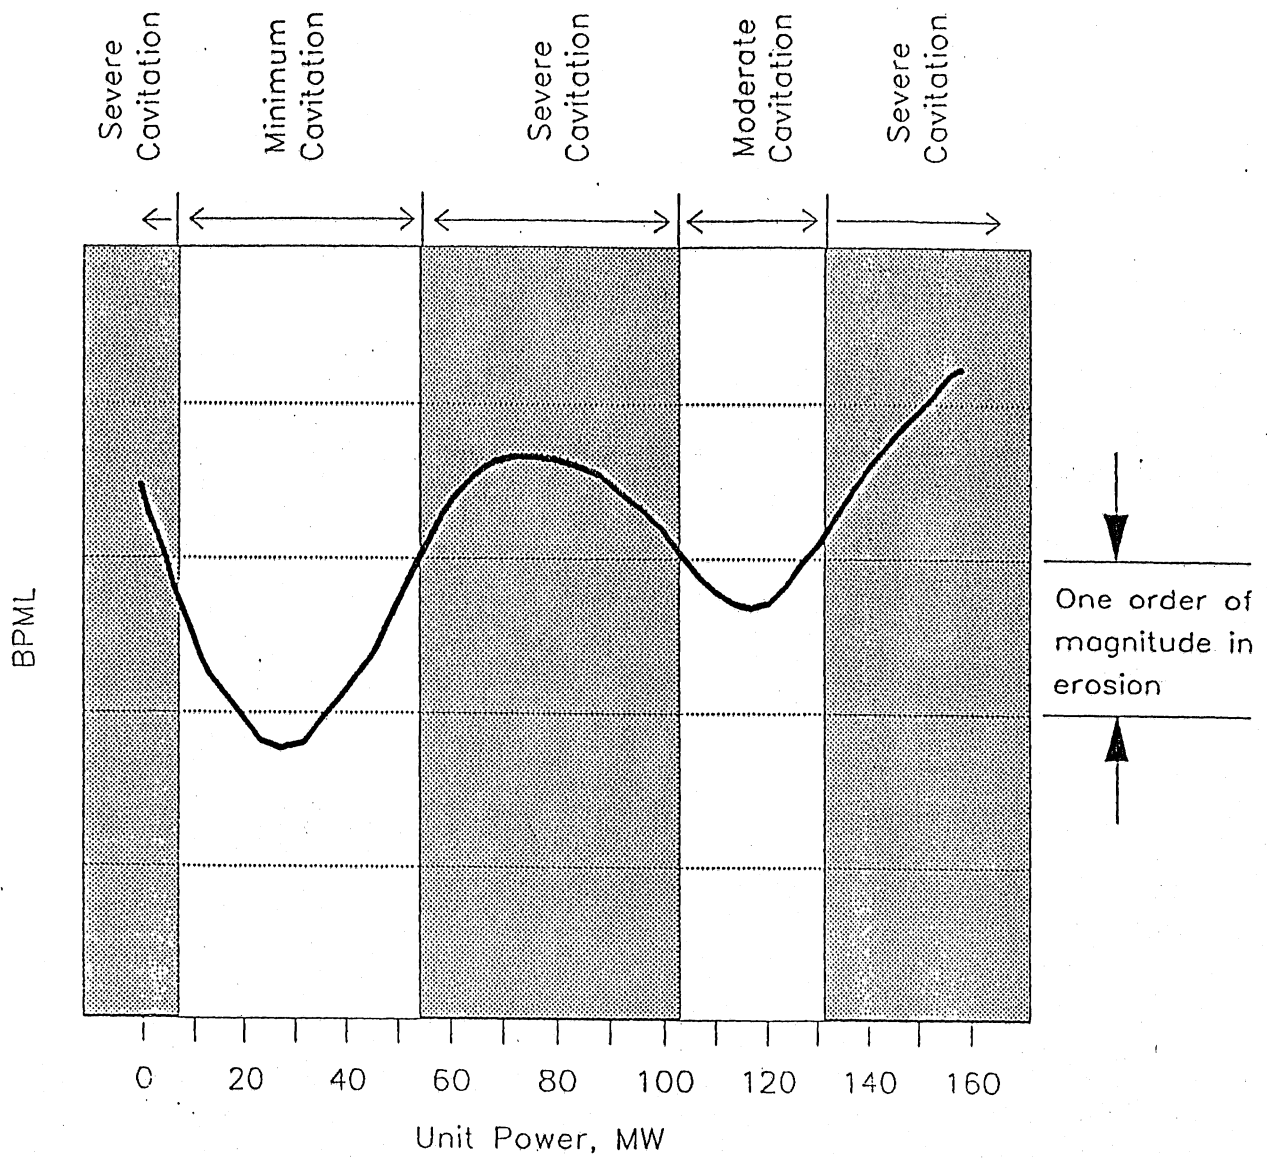
Figure 3. Erosion intensity measured in the Kerckhoff 2 turbine (Shanahan and Abbot, 1993).

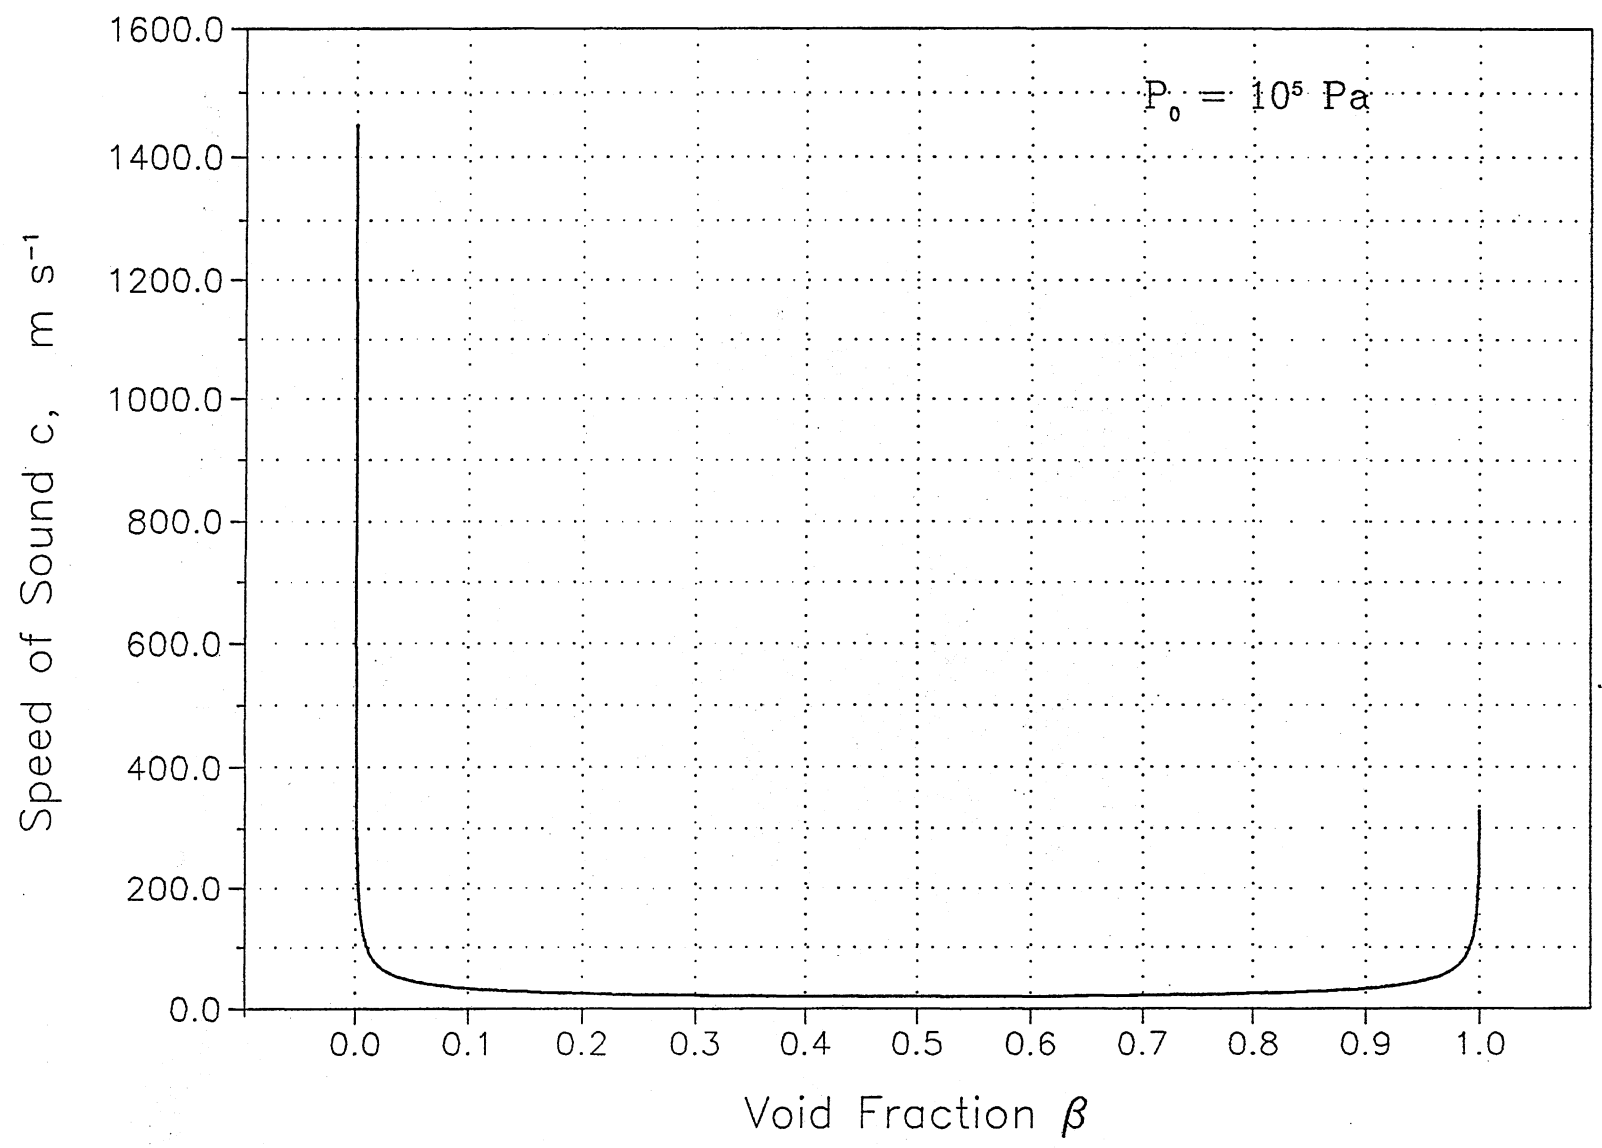
Figure 4. Speed of sound in bubbly liquid.

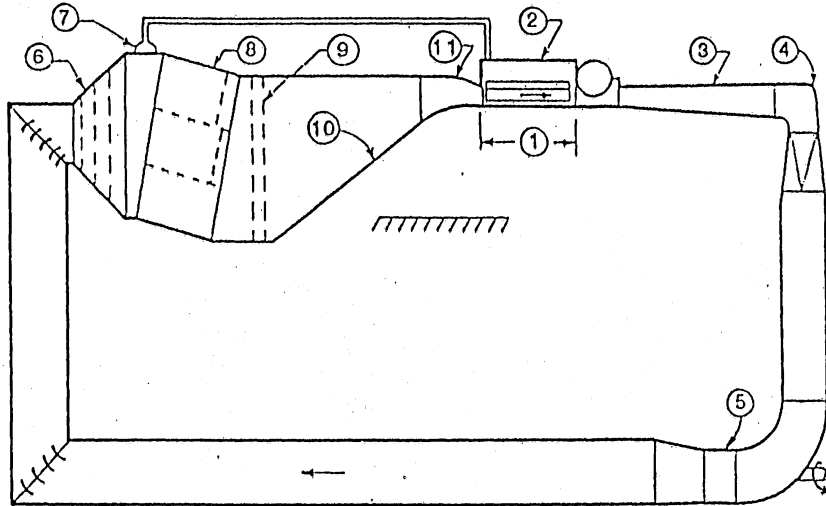
Figure 5a. Schematic of SAFHL high speed water tunnel.

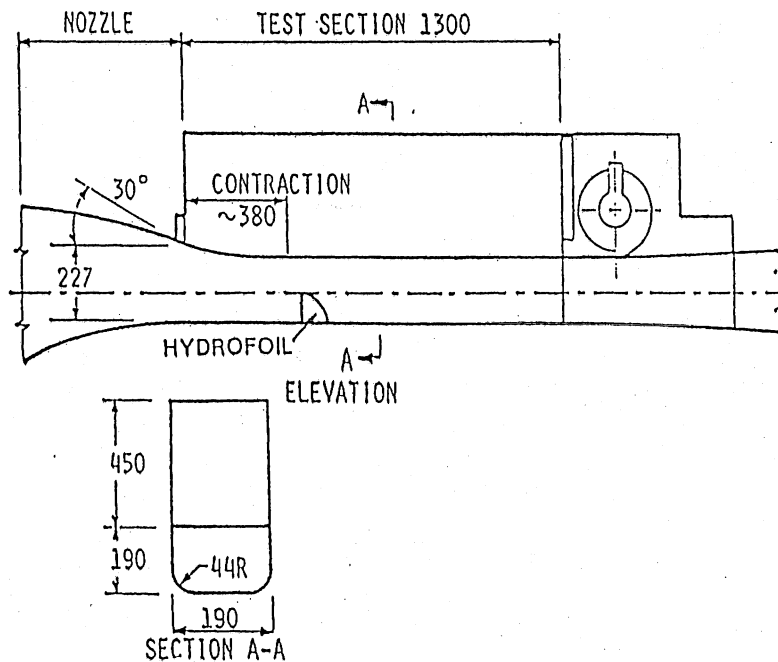
Figure 5b. Test section configuration.

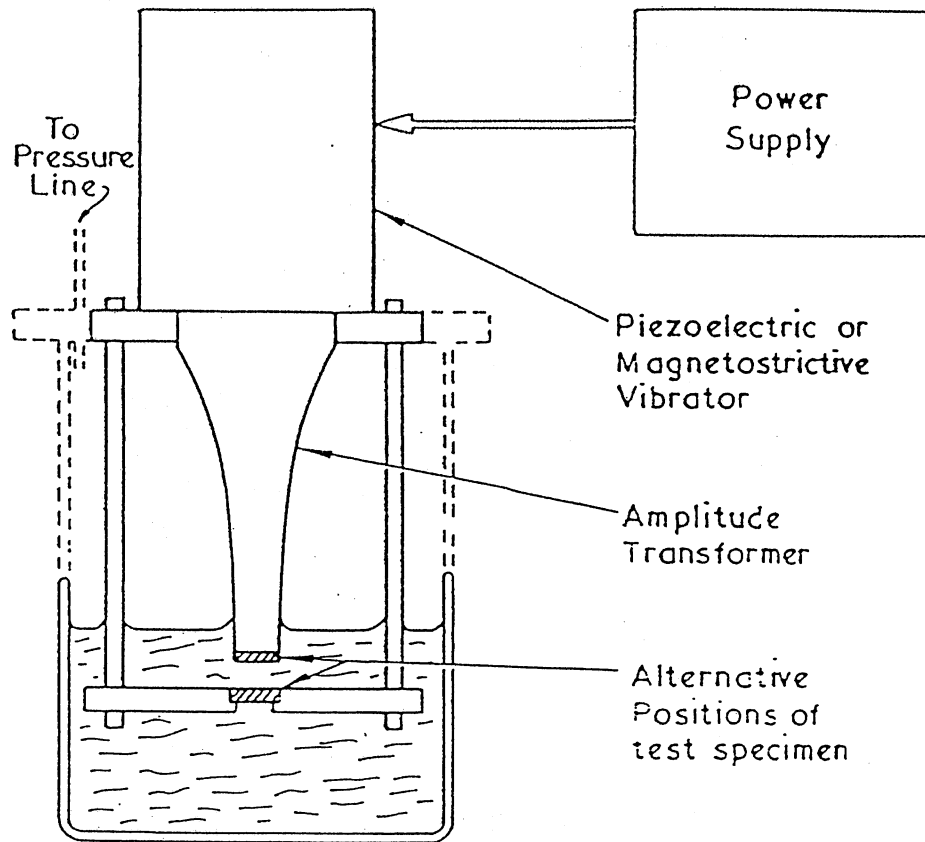
Figure 6. Schematic of the vibratory cavitation setup.

Vibratory cavitation tests were conducted with the ASTM G-32 procedure. The apparatus as shown in Figure 6, is a modification to allow for cavitation erosion tests on a stationary specimen. In accordance with the standards the vibration at the horn tip was set at a frequency of 20 KHz with an amplitude of $50 \mu\text{m}$ peak-to-peak. It has been observed in previous studies that the erosion rate of stationary specimen strictly depends upon its standoff distance from the face of the vibrating element. The standoff distance during this investigation was maintained at approximately 1.5 mm for most of the experimental work.

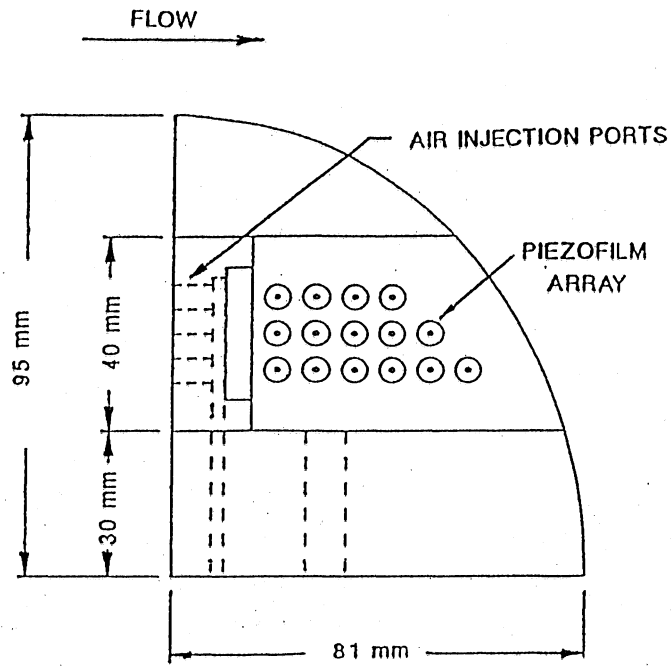
Figure 7a. Details of hydrofoil.

The foil is fitted with interchangeable leading edges. One of which was blank while the other had 5 grooves, that when in position created 5 holes at the leading edge of 0.5 mm diameter spaced 5 mm apart. These dimensions were selected on the basis of a number of previous studies on air injection for other purposes. Interchangeable inserts are also provided at mid-span as shown. One type of insert is machined of commercially pure aluminum for pitting studies. This can be replaced by an instrumented insert machined out of PVC plastic.

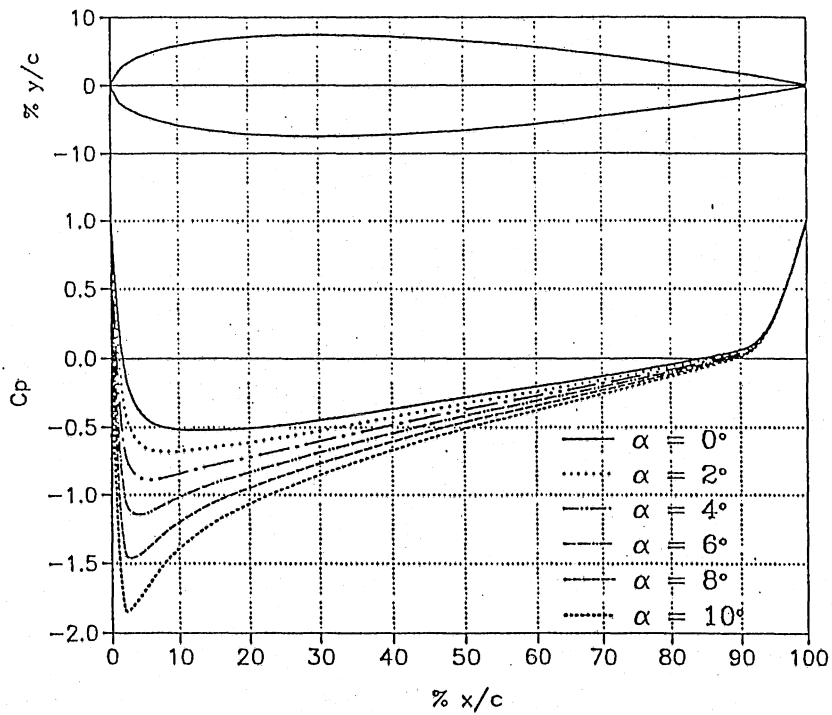
Figure 7b. Chordwise pressure distribution.

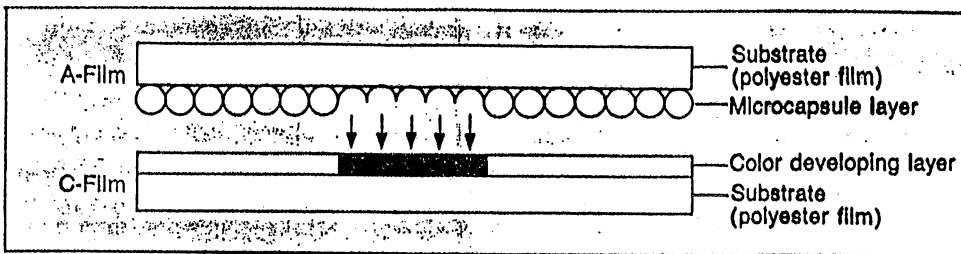
Figure 8a. Schematic of the pressure detecting film "Prescale" (adapted from Fujifilm Imaging & Information, Fuji Photo Film Co., Ltd., Japan).

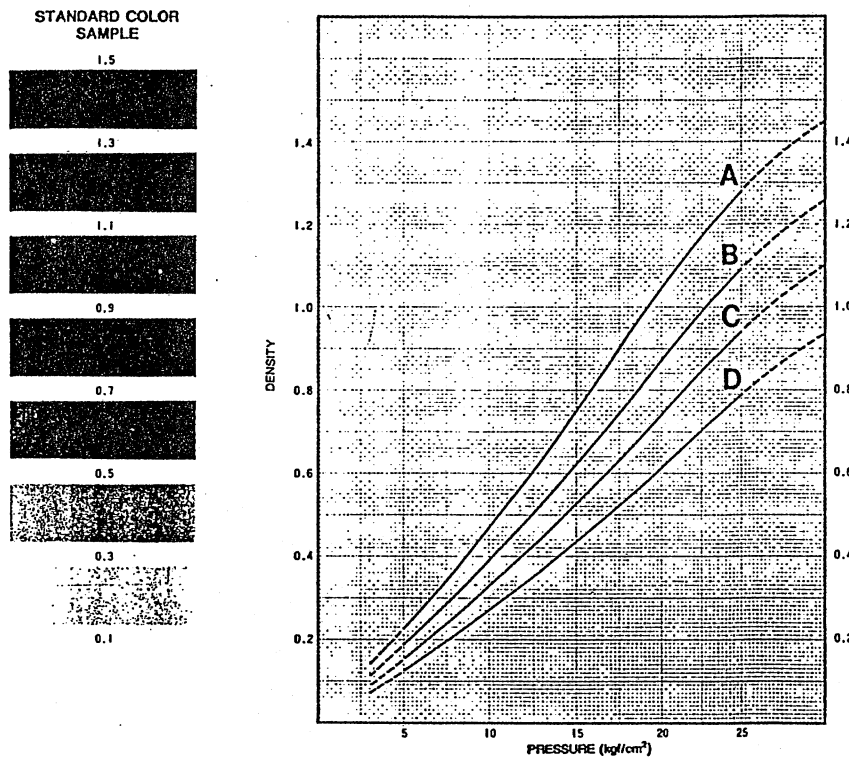
Figure 8b. Typical pressure calibration of the color density from "Prescale" exposed to momentary pressure (adapted from Instruction Manual, Fuji Prescale Film, Fuji Photo Film Co., Ltd., Japan).

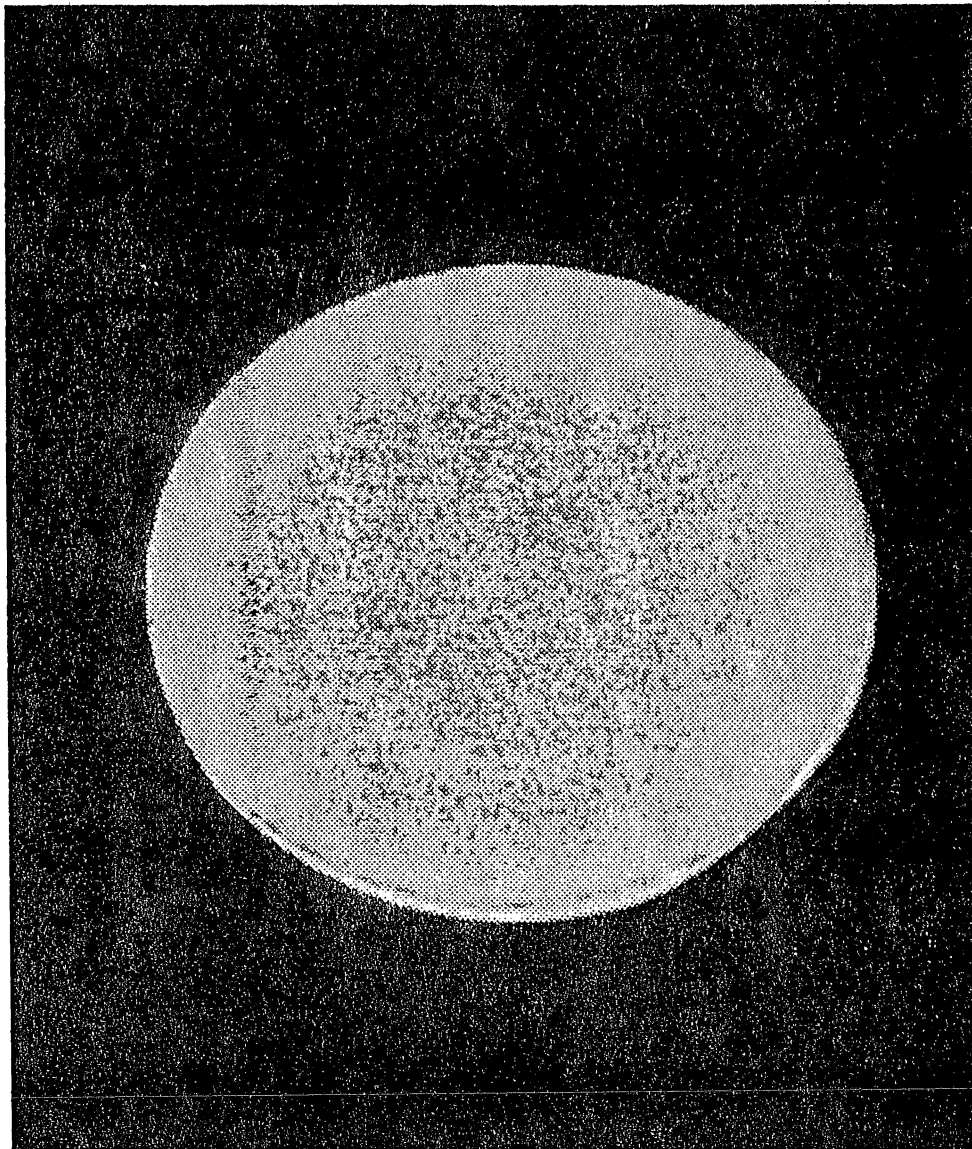
Figure 9a. Computer output of a digitized image acquired through the frame grabber. "Prescale" film exposed for 5 seconds at a standoff distance of 1.5 mm from the face of the horn.

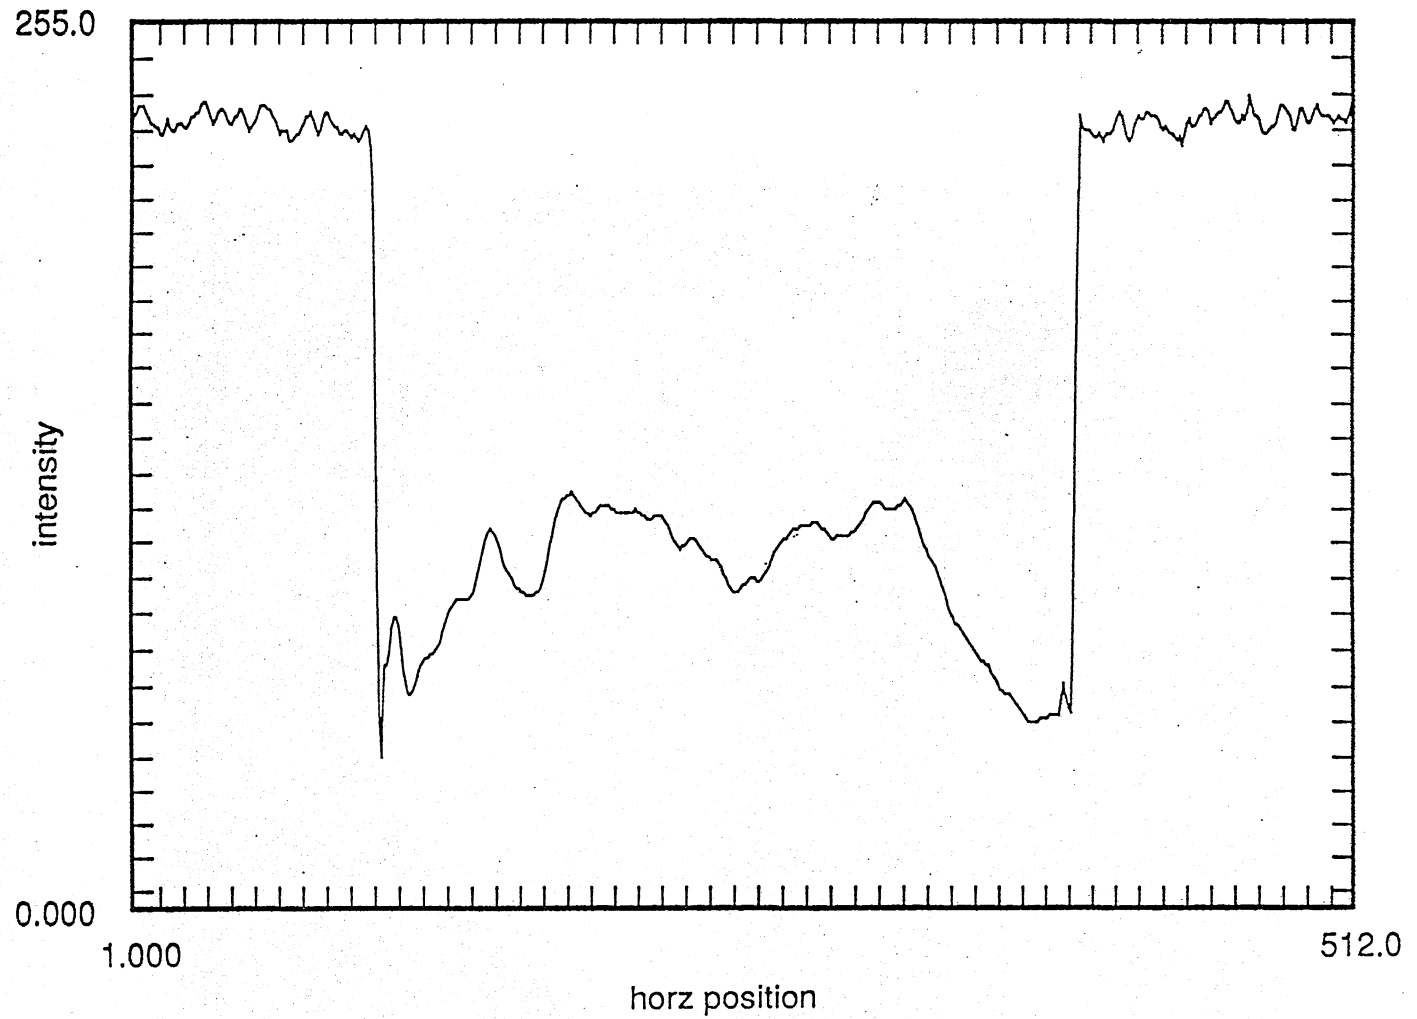
Figure 9b. Variation of the pressure field along the diameter of a stationary specimen placed under the horn at a standoff distance of 1.5 mm. Exposure time was 5 seconds. Numerical smoothing was performed on 7 x 7 over 7 x 7 pixels.

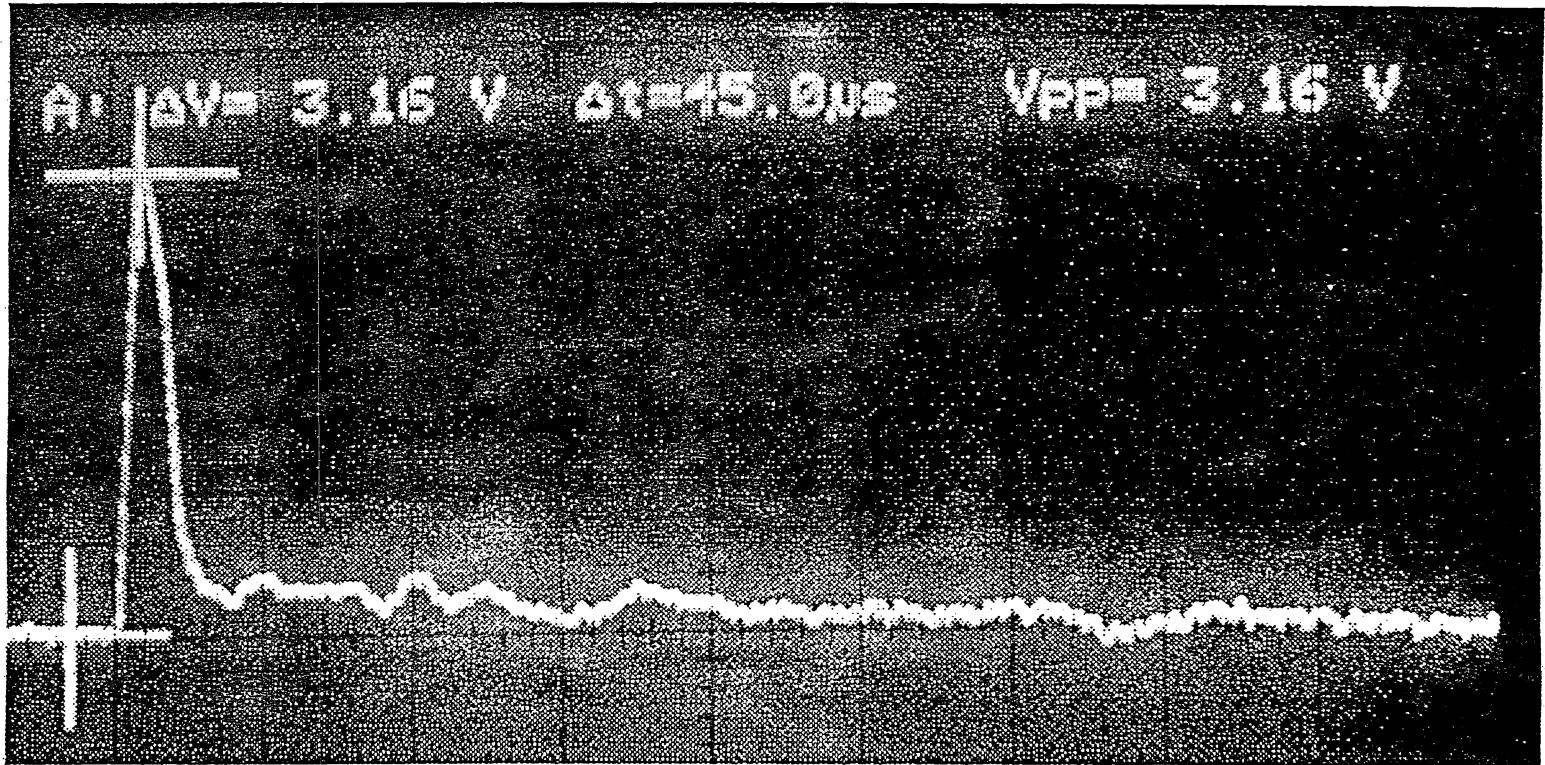
Figure 10. Time trace of the pressure signal acquired on the oscilloscope during the dropping ball calibration test.

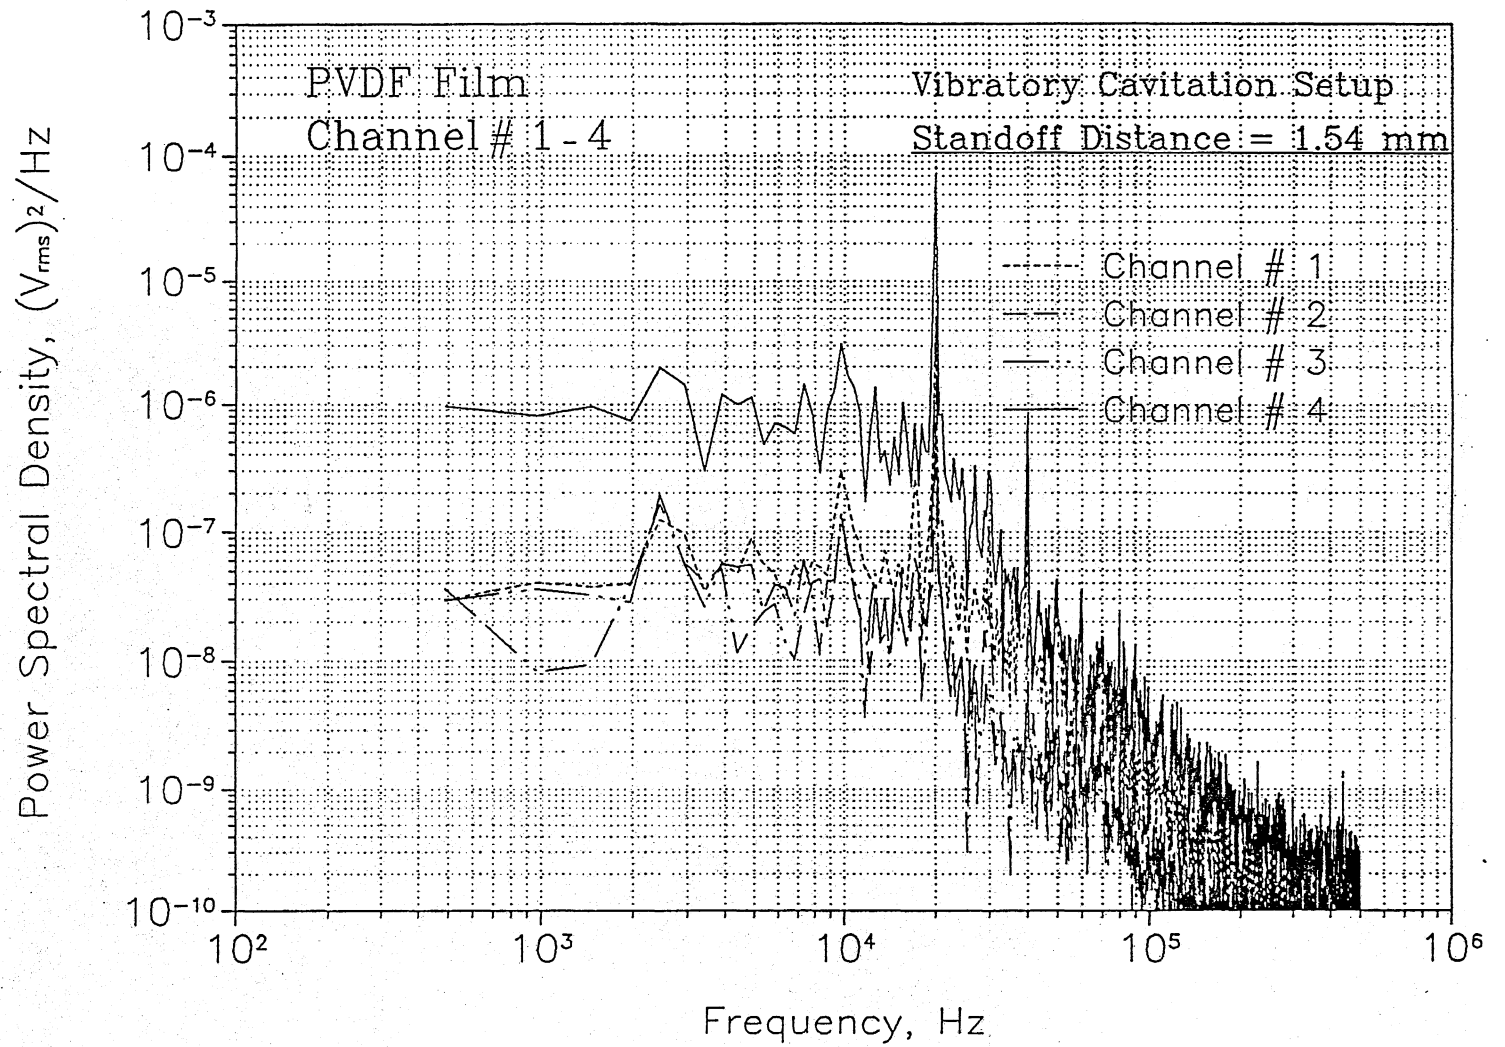
Figure 11. Measured pressure spectra beneath the horn in the ASTM vibratory apparatus.

Several different types of tests were carried out with the vibratory apparatus in the course of developing the PVDF transducers. Figure 11 shows the power spectrum measured beneath the horn with 6.35 mm diameter transducers at a stand-off distance of 1.54 mm. Channel 4 is from a transducer positioned at centerline of the horn. Channels 1, 2, and 3 are from transducers each positioned at a radial offset distance of 7.94 mm and angles of 0° , 90° , and 180° . A common ground was positioned at 270° . As expected, a strong peak is noted at a vibration frequency of 20 KHz with another peak at the first harmonic of 40 KHz. The signal from the centerline transducer is higher, as expected. Some discrepancies are noted in the signals from the other three transducers, which should be identical.

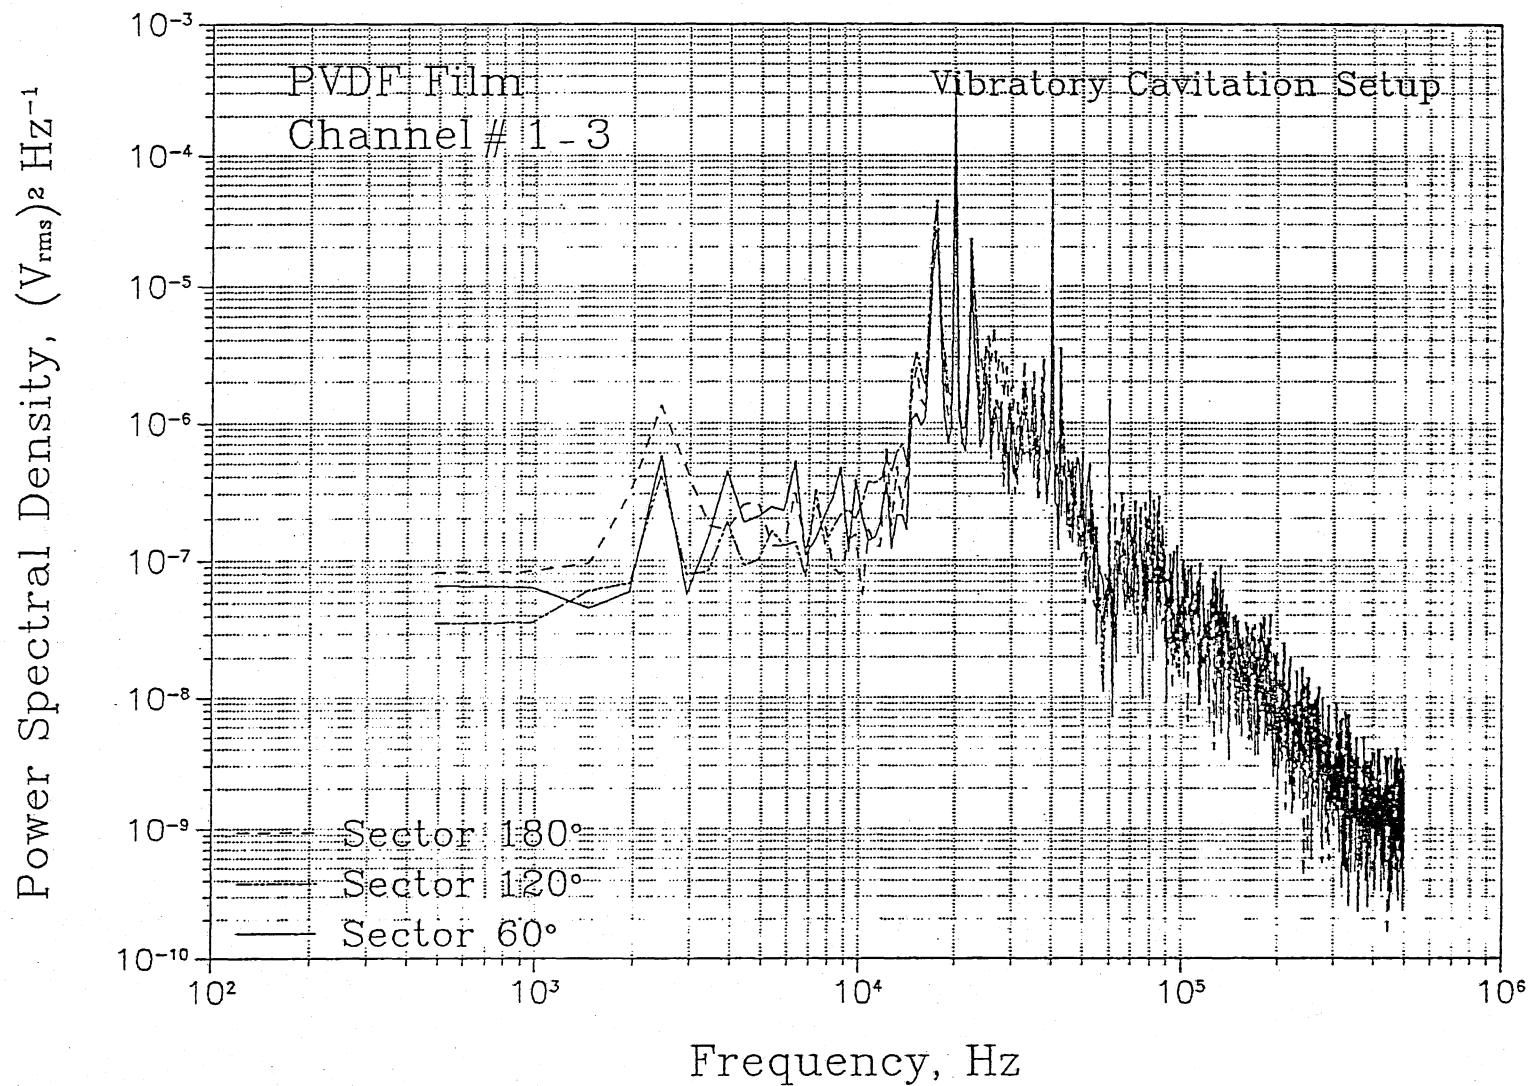
Figure 12. Measured pressure spectra of the signal from three pie-shaped piezoelectric sensors beneath the horn in the ASTM vibratory cavitation apparatus.

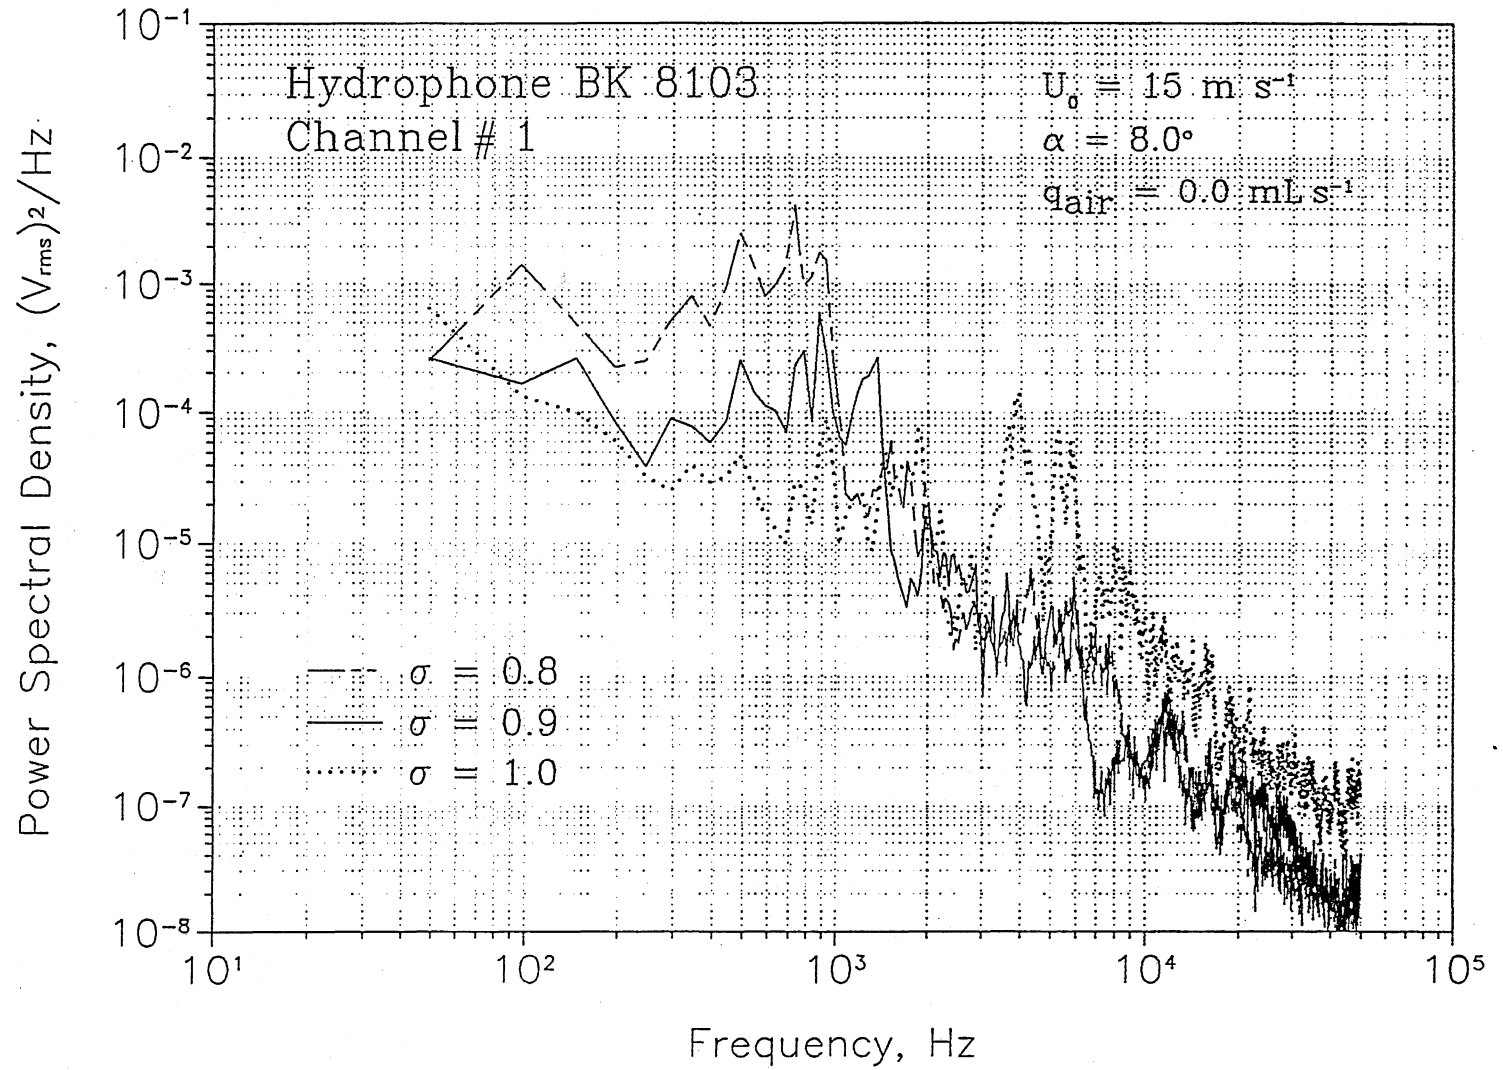
Figure 13. Cavitation noise spectra measured at $U_0 = 15 \text{ m s}^{-1}$.

Figures 13 and 14 contain noise data collected at various values of σ and flow velocity. In Figure 13 a comparison is made at $U_0 = 15 \text{ m s}^{-1}$ between spectra collected at $\sigma = 0.8$, 0.9 , and 1 . The high frequency decay is 6 dB/octave which is typical for cavitation noise. The level of low frequency noise increases with decreasing σ , but the high frequency noise level is highest at $\sigma = 1.0$. At higher velocities, Figure 14, the same trend with σ is noted for the low frequency noise, but

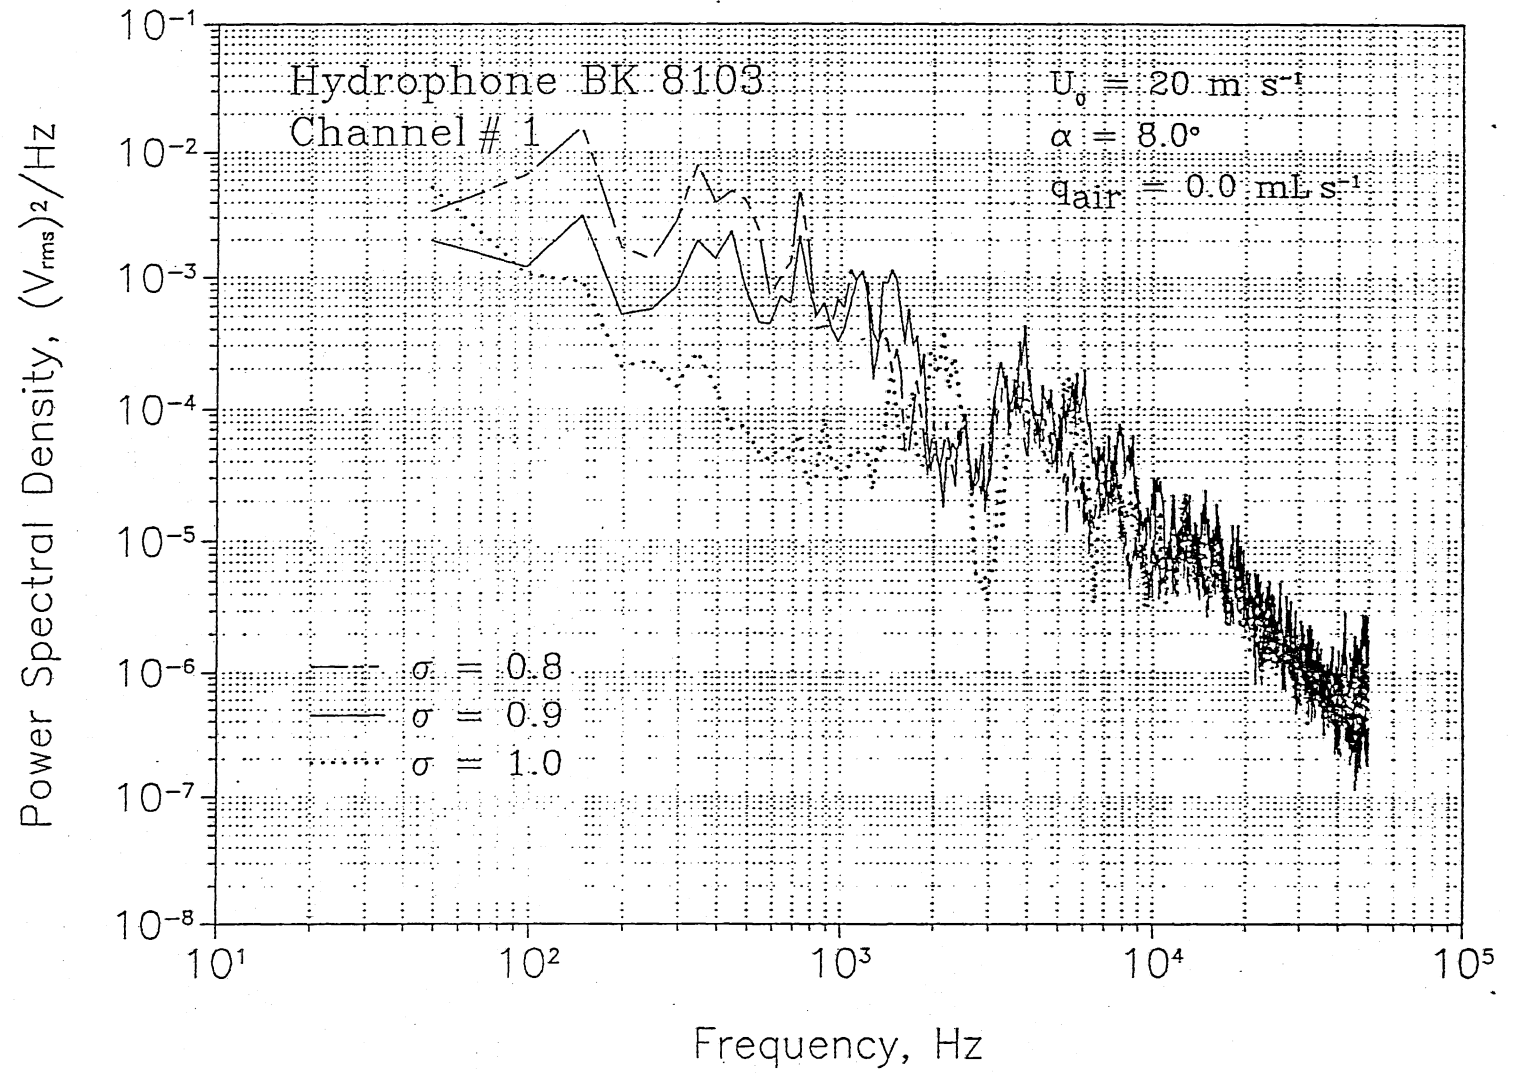
Figure 14. Cavitation noise spectra measured at $U_0 = 20 \text{ m s}^{-1}$.

the high frequency noise appears to be independent of σ . This characteristic is not completely understood. It was also noted that the scaling of cavitation noise with velocity did not agree with the pressure data or the accelerometer data. Presumably the acoustic path between the hydrofoil and the hydrophones was modified by cavitation.
