UNIVERSITY OF MINNESOTA
ST. ANTHONY FALLS HYDRAULIC LABORATORY

Project Report No. 343

**Investigation of the Use of Air Injection
to Mitigate Cavitation Erosion**

Pacific Gas and Electric Company
San Francisco, California

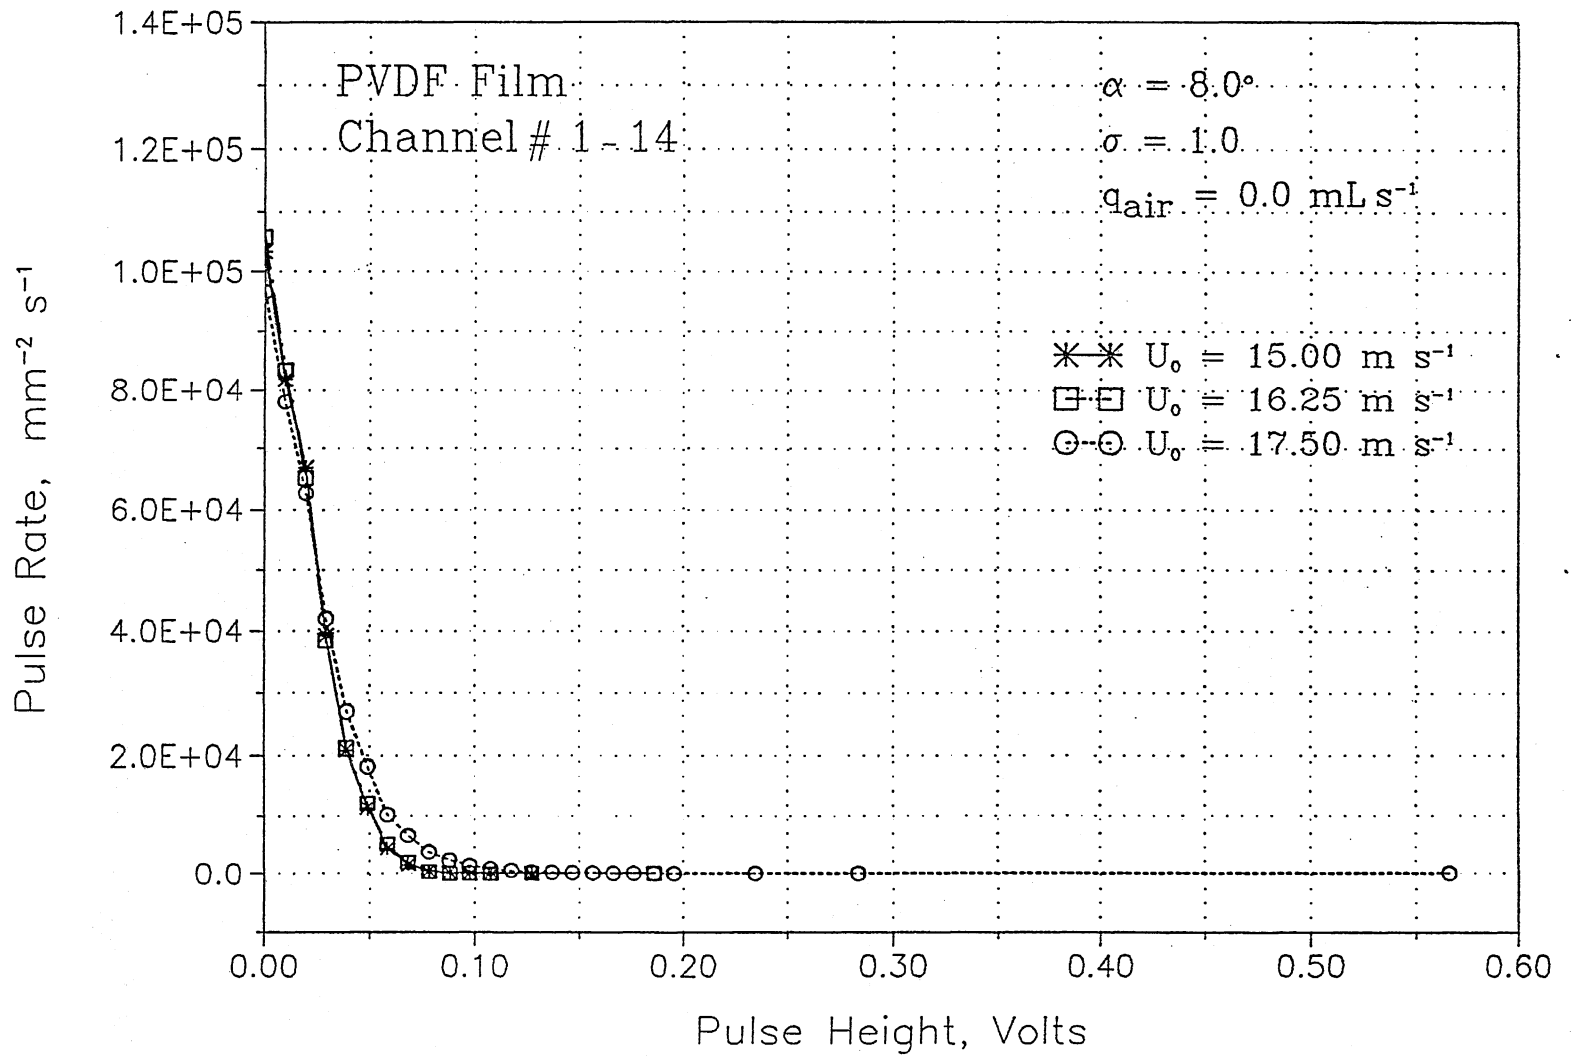
Figure 15. Comparison of pressure pulse height spectra at different velocities.

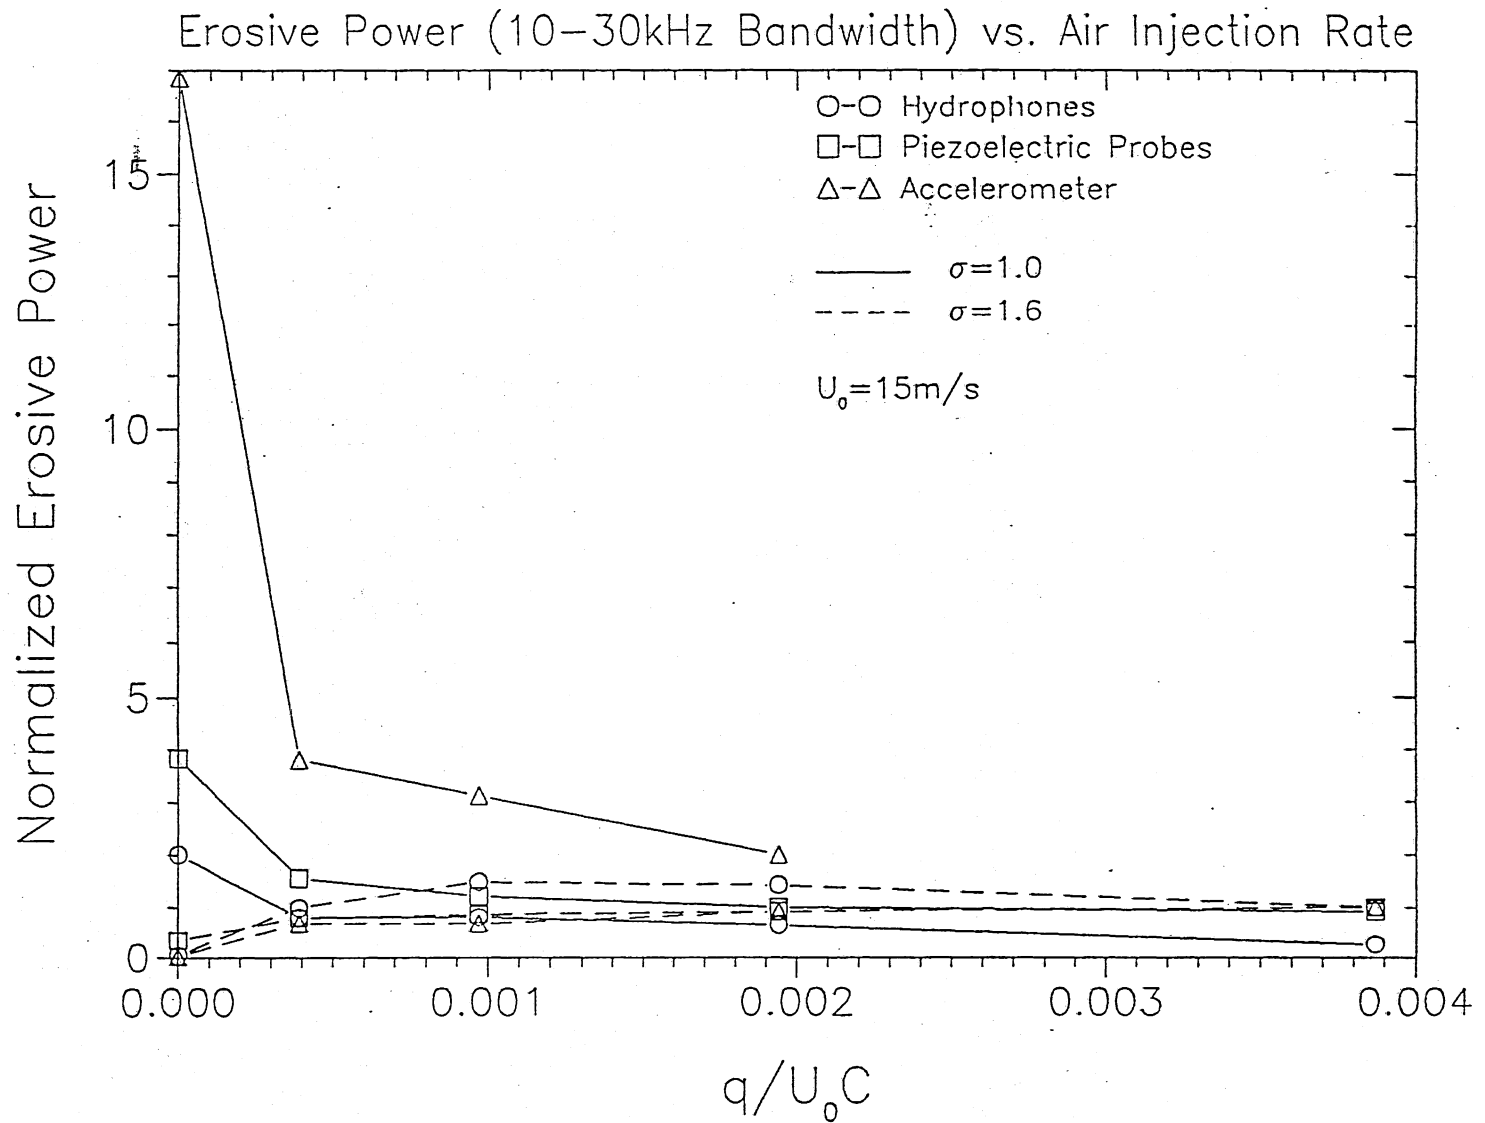
Figure 16. Comparison of normalized erosion power versus normalized air flow rate at $U_0 = 15 \text{ m s}^{-1}$, $\sigma = 0.9$.

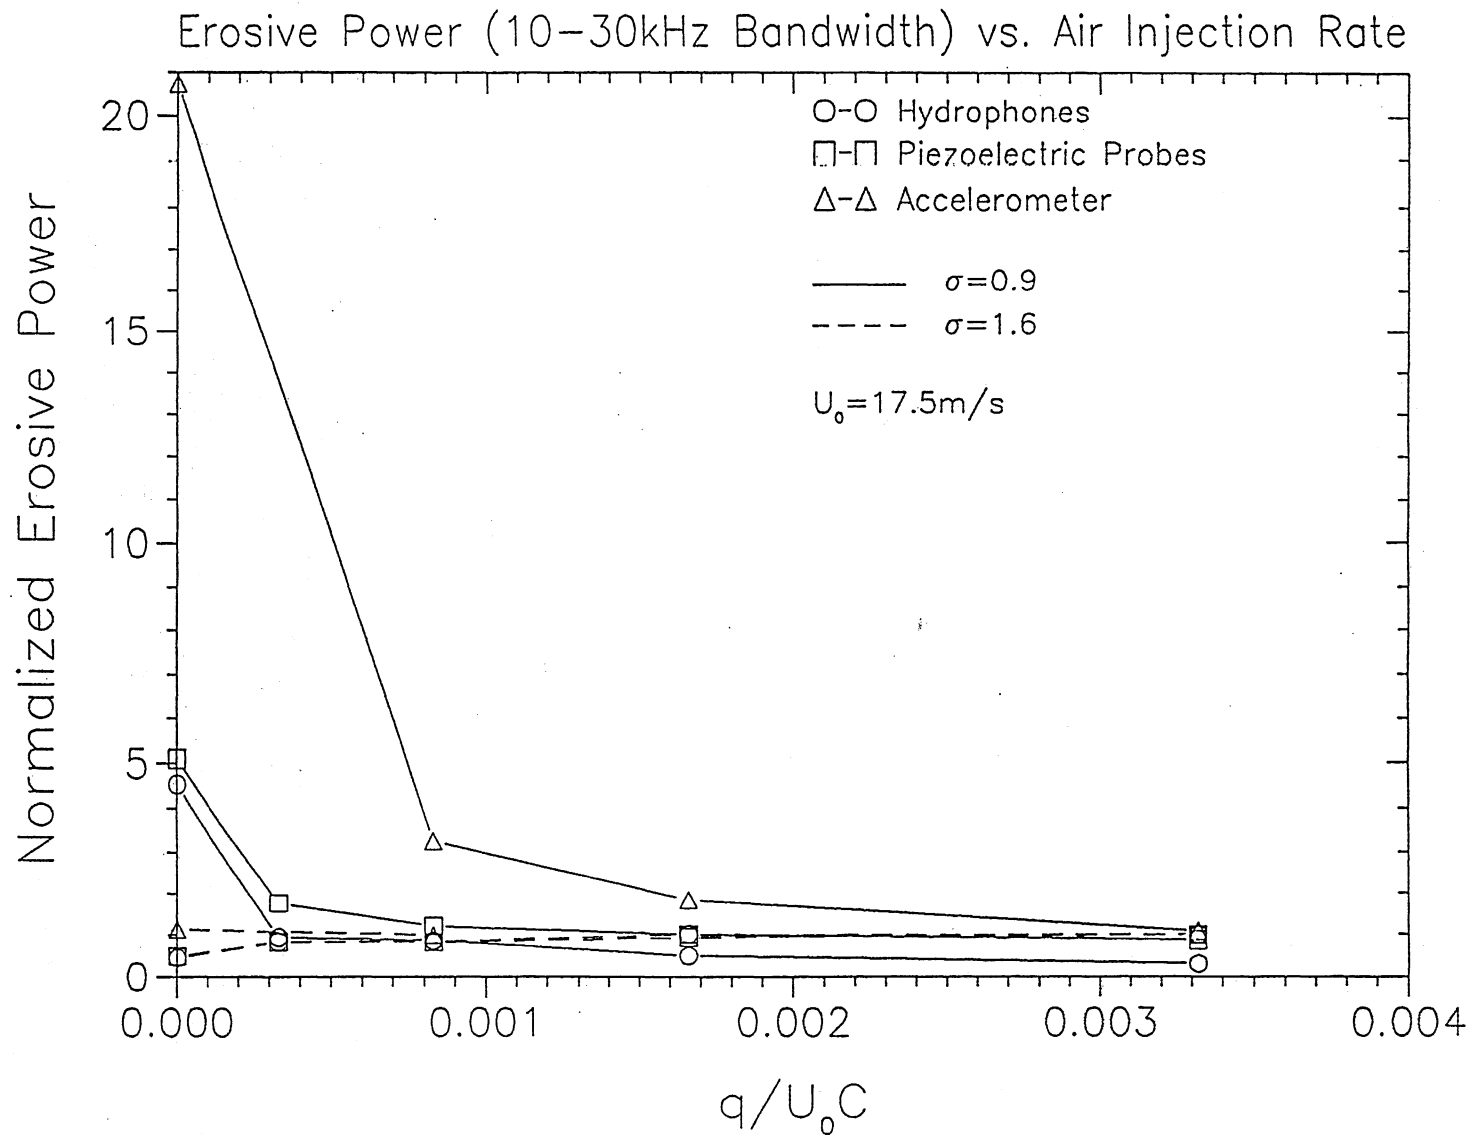
Figure 17. Comparison of normalized erosion power versus normalized air flow rate at $U_0 = 17.5 \text{ m s}^{-1}$, $\sigma = 0.9$.

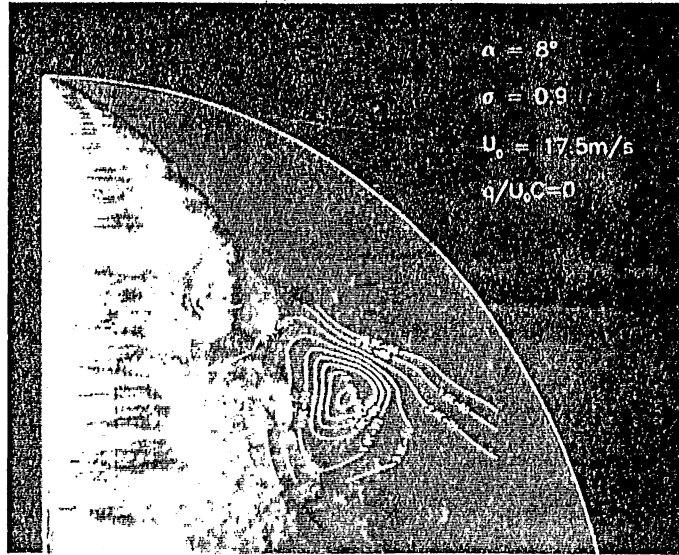
Figure 18. Photograph of sheet cavitation at $\sigma = 0.9$ and $U_0 = 17.5 \text{ m s}^{-1}$. Superimposed on the plot are isobars of mean square pressure fluctuations.

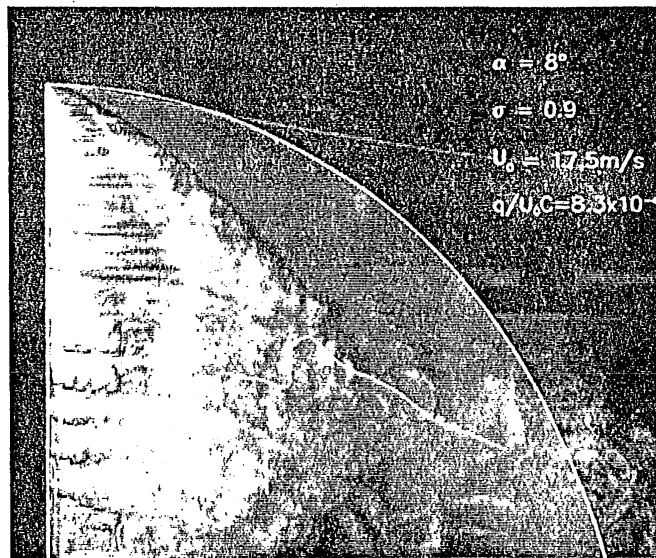
Figure 19. This is the same situation as Figure 18 except for an air injection rate, $q/U_0 c$ of 8.3×10^{-4} . Note the dramatic reduction in pressure intensity over the entire surface of the foil.

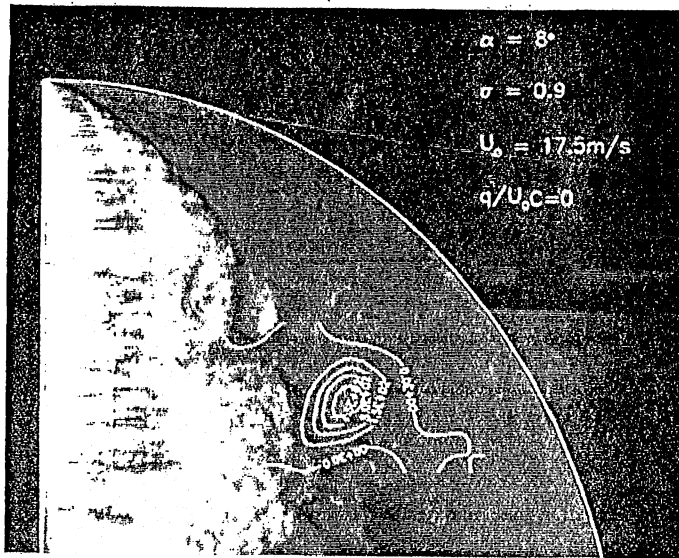
Figure 20. Photograph of sheet cavitation at $\sigma = 0.9$ and $U_0 = 17.5 \text{ m s}^{-1}$. Superimposed on the plot are isobars of the number of pulses exceeding a predetermined critical level.

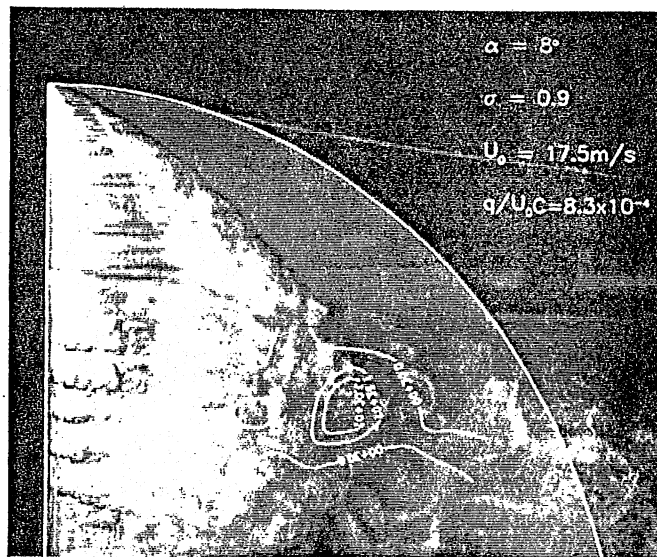
Figure 21. This is the same situation as Figure 20 except for an air injection rate, $q/U_0 c$, of 8.3×10^{-4} . Note the dramatic reduction in amplitude of the pressure pulses over the surface of the foil.

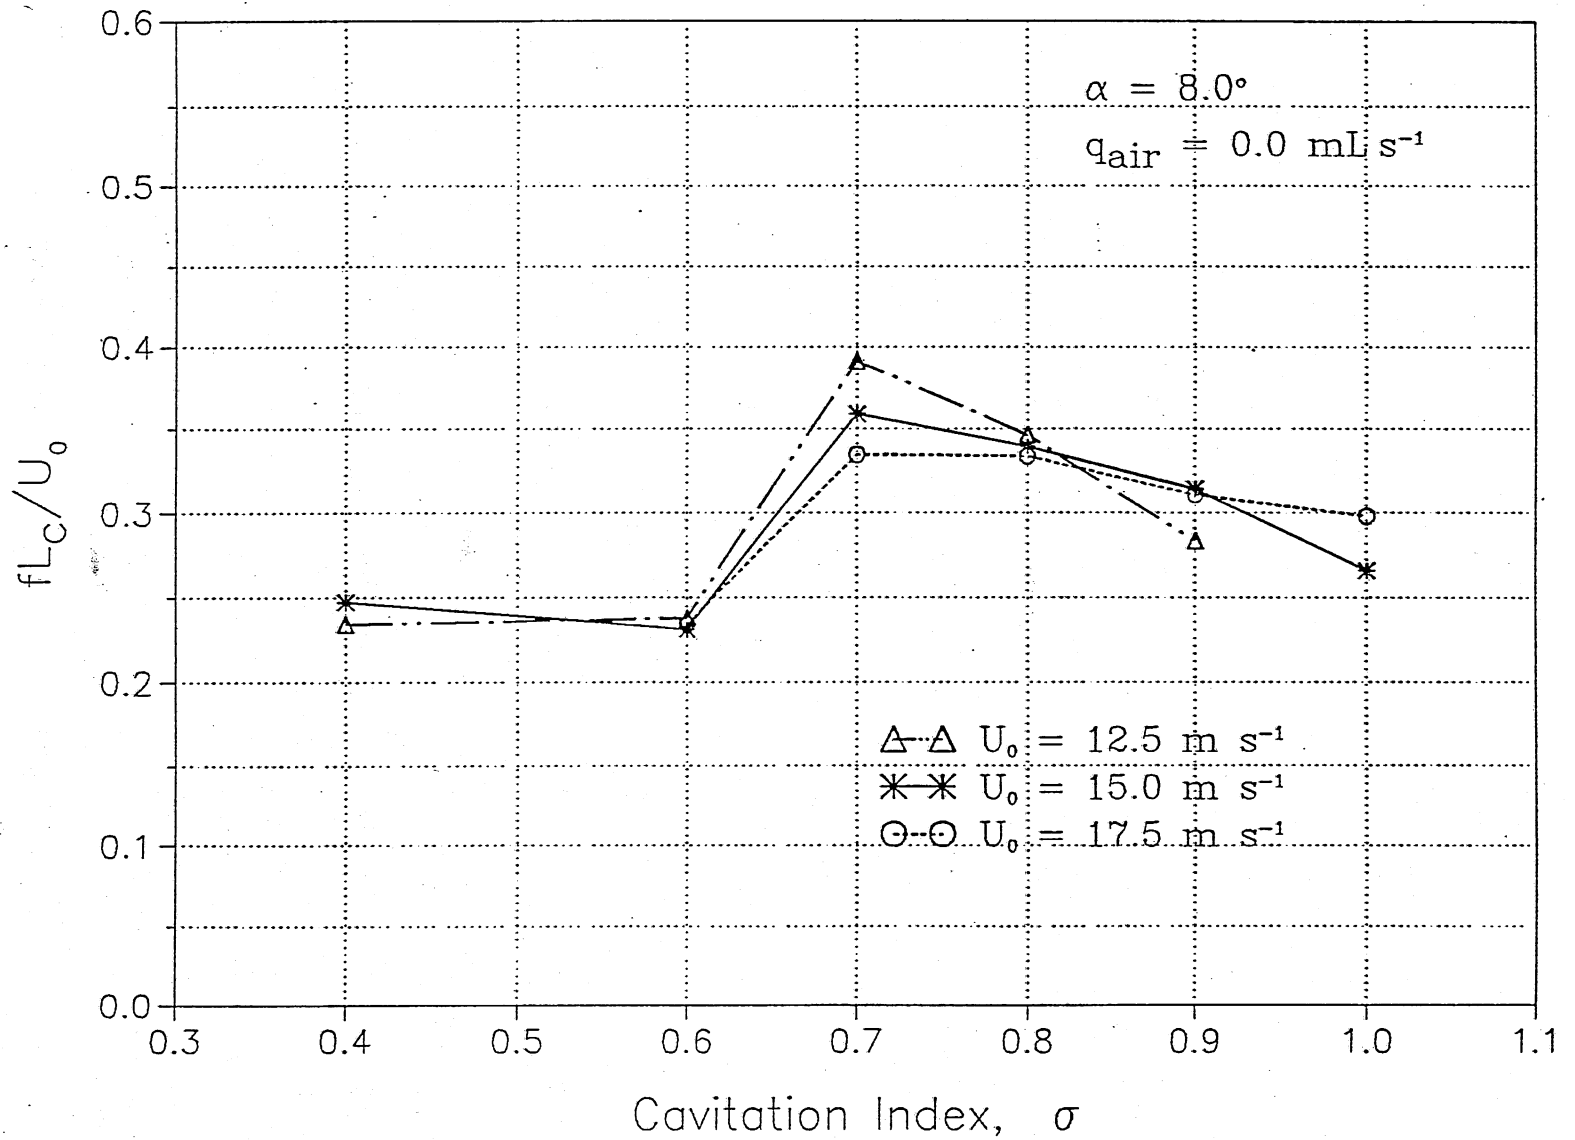
Figure 22. Variation of the modulation frequency with σ at $U_0 = 12.5, 15.0$ and 17.5 m s^{-1} .

Since L_c varies strongly with σ , most of the observed variation in modulation frequency with σ is removed by using L_c as the characteristic length scale. This is shown in Figure 22. The frequency of oscillation is obtained from the modulation analysis and agreed almost perfectly with cavity oscillation frequency data obtained visually using a stroboscope.
